4. EXISTING CONDITIONS

TRANSPORTATION IMPROVEMENTS
DONALD COUSENS PARKWAY TO MORNINGSIDE AVENUE LINK
(formerly Transportation Improvements
in the Markham Bypass Corridor South of Highway 407)
ENVIRONMENTAL ASSESSMENT

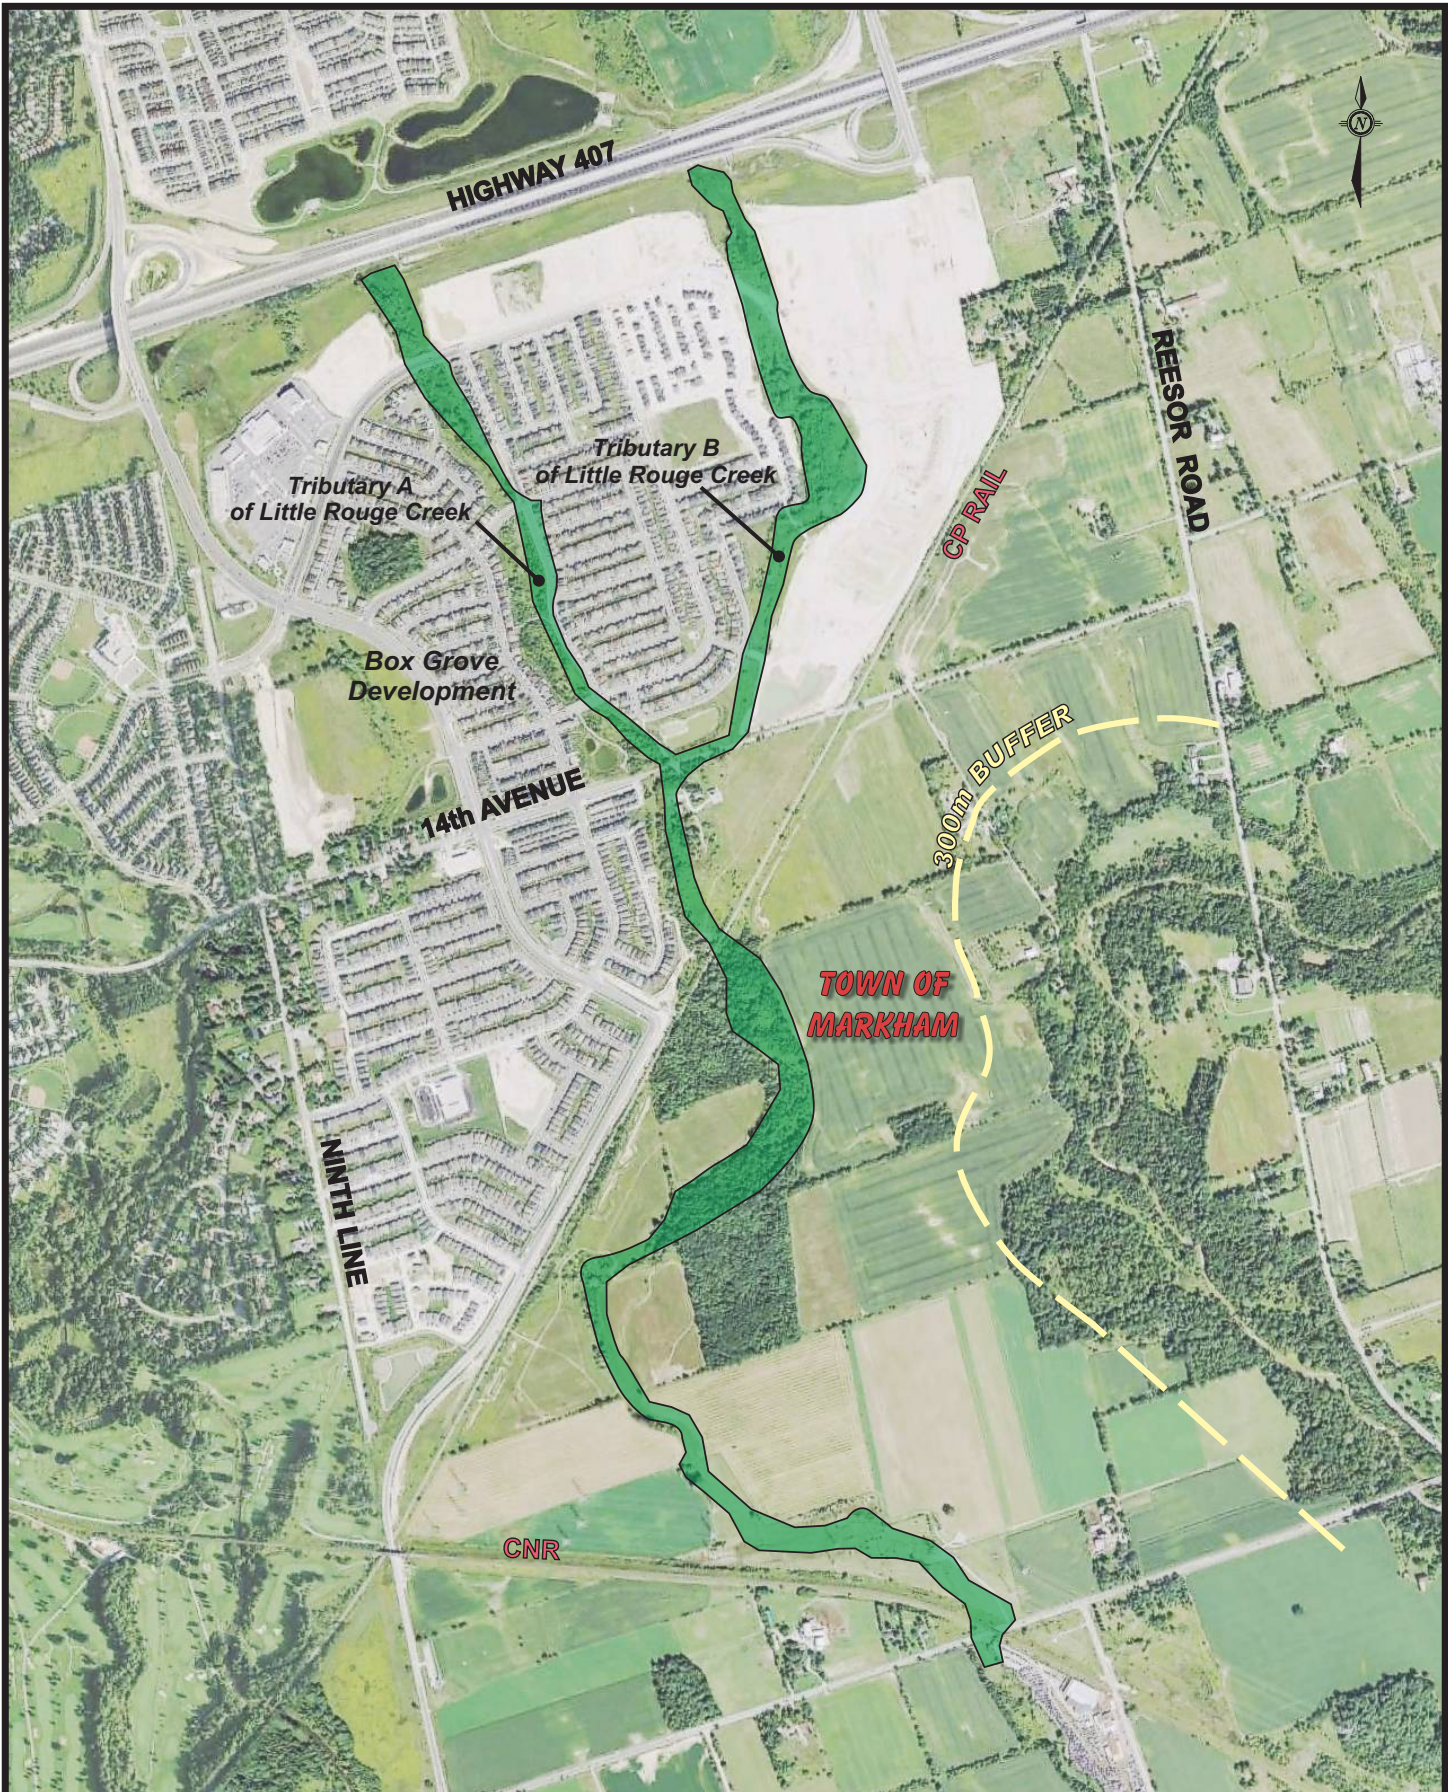
EXHIBIT
 4-2b

BOX GROVE DEVELOPMENT AREA
 (2009 Aerial)

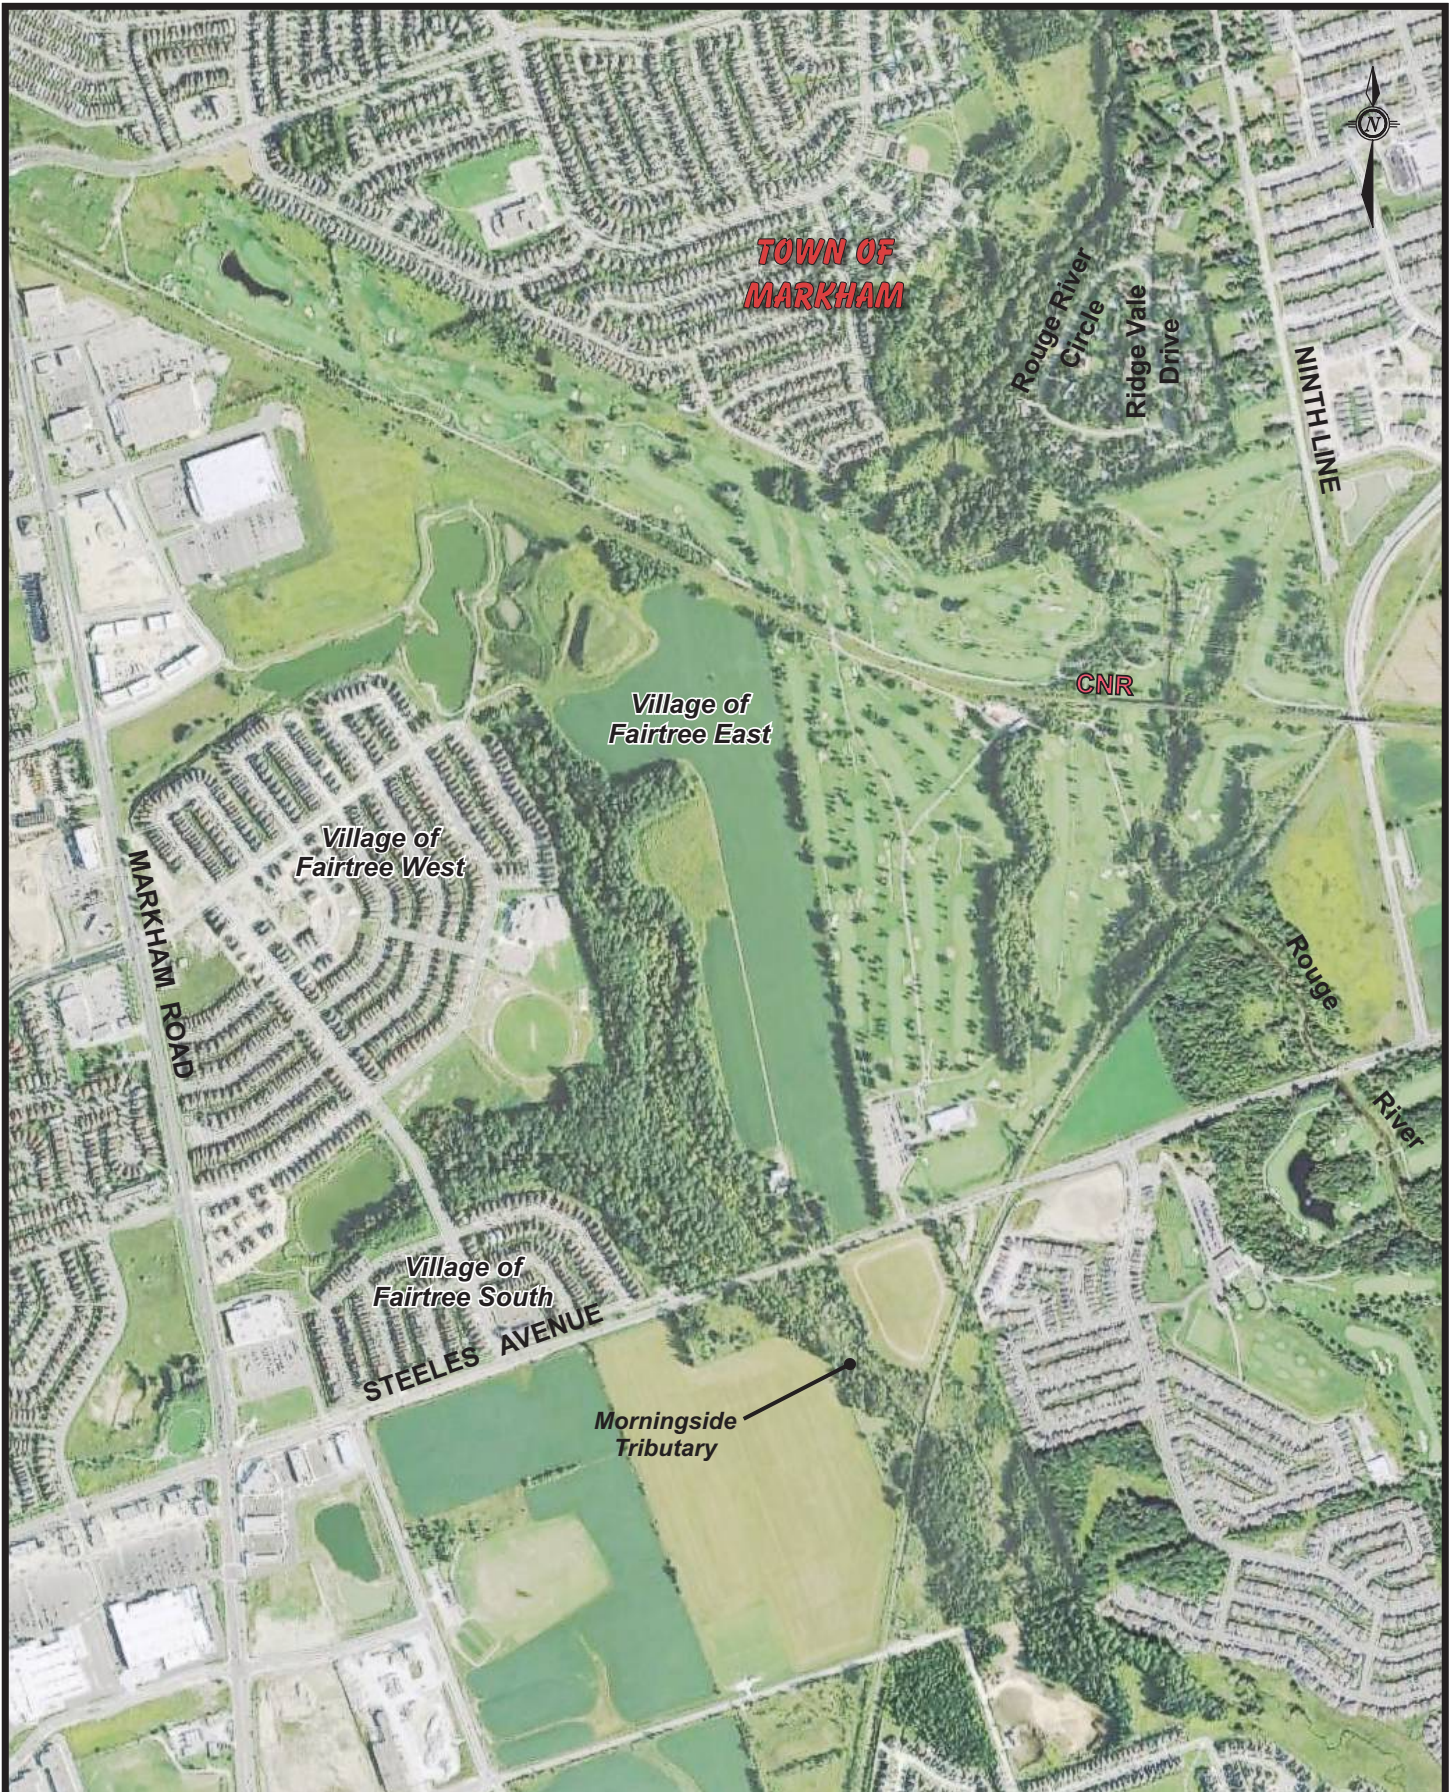
EXHIBIT
4-3b

VILLAGE OF FAIRTREE
(2009 Aerial)

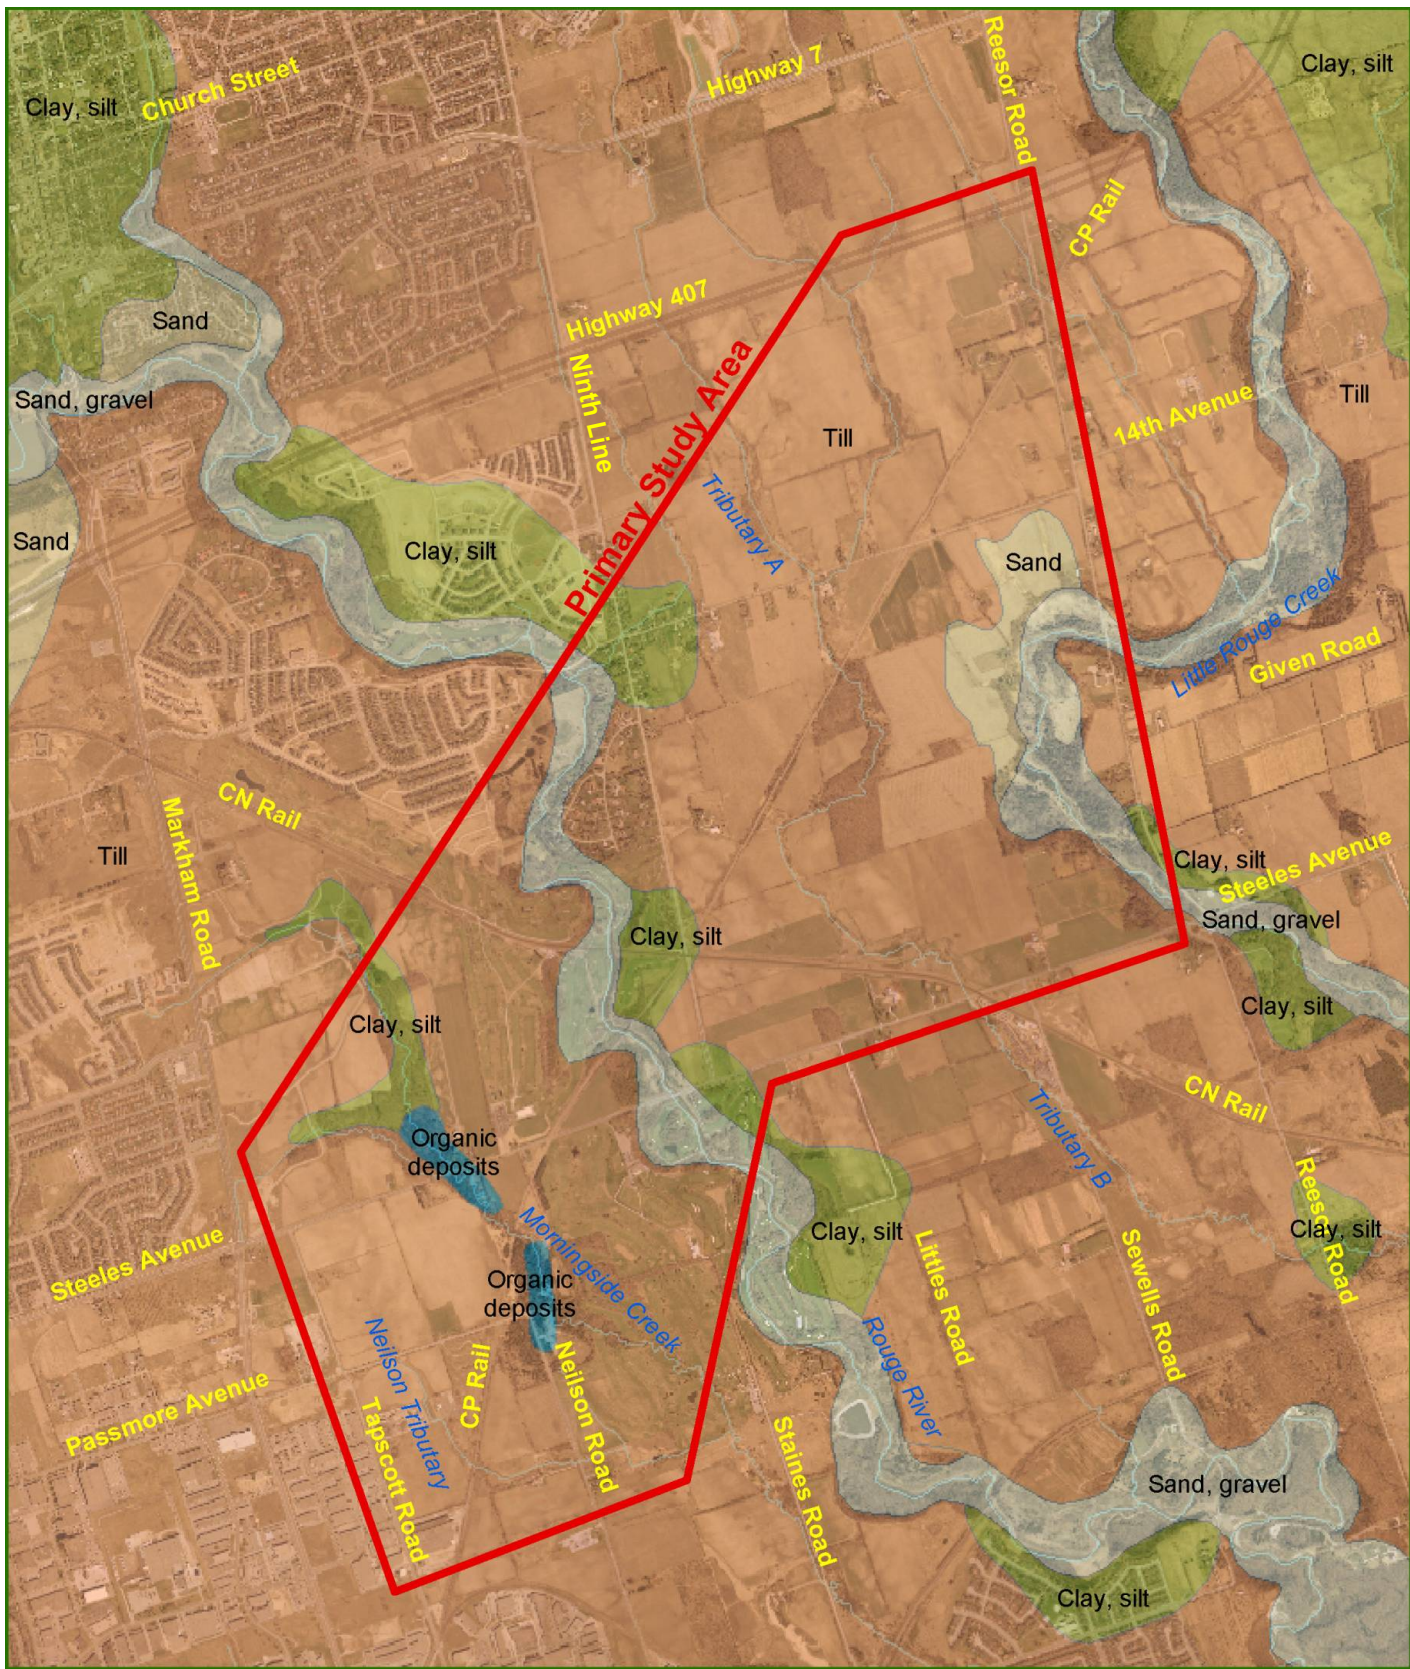
SURFICIAL GEOLOGY

Surficial geology within the Donald Cousens Parkway primary Study Area is characterized predominantly by glacial calcareous till on the tablelands (including along Tributaries A and B) with sand/gravel deposits in the Rouge River and Little Rouge Creek Valleys. Additional clay/silt and sand deposits are found adjacent to Little Rouge Creek and the Rouge River. Surficial materials along Morningside Tributary are predominantly till with some clay/silt and organic deposits present (Ontario Geological Survey, Ministry of Northern Development and Mines 2003). Surficial geology is mapped on Exhibit 4-5.

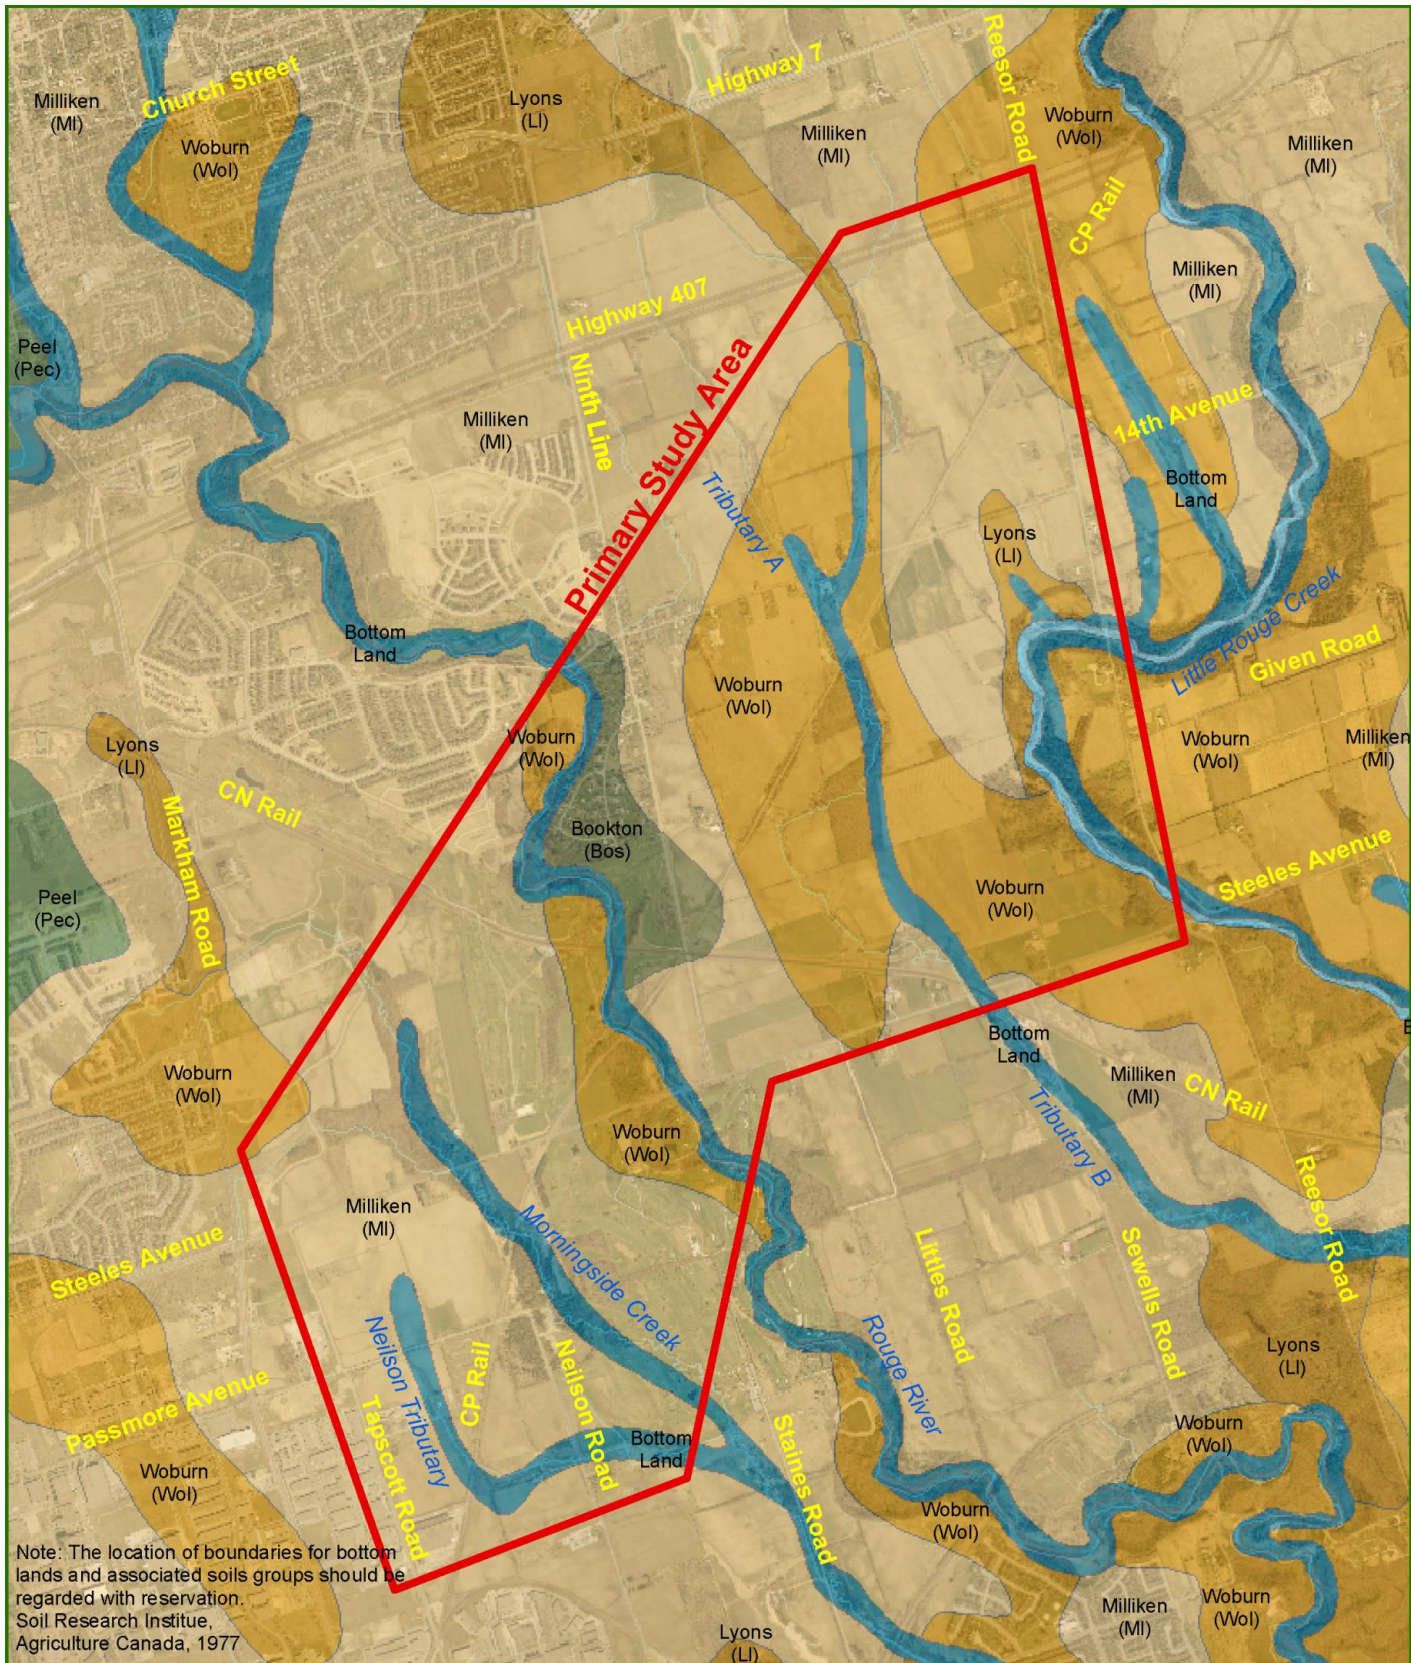
The Woburn, Milliken and Bookton series soil types are classified as Grey-Brown Podzolic soils. Both the Milliken and Woburn soils have developed on medium textured shale and limestone till. Milliken loam is imperfectly drained with little surface stoniness and occurs on gently to moderately sloping topography. It covers much of the Study Area and has little potential for erosion except where moderate slopes cause rapid runoff. The Woburn loam soil type is well drained with little surface stoniness, occurs on smooth to steeply sloping topography and can be susceptible to sheet erosion. It is primarily associated with the Rouge River, Tributary B and Little Rouge Creek. A small amount of poorly drained Lyons loam is associated with the Little Rouge Creek. Lyons loam is classified as a dark grey Gleisolic soil, has little surface stoniness, occurs on very gently sloping topography and is not susceptible to erosion. Bookton sandy loam, primarily associated with the Rouge River in the central part of the Study Area, has developed on sandy outwash materials underlain by clay till. It is well drained, stone free and occurs on gently sloping topography. Bottom Land / alluvials are the immature soils (with limited horizon development) found along stream corridors, and are subject to flooding. Bottom Land soil types vary in their topography and drainage (although it is usually poor), but are stone free and occur on recently deposited alluvium materials.

| Milliken Loam

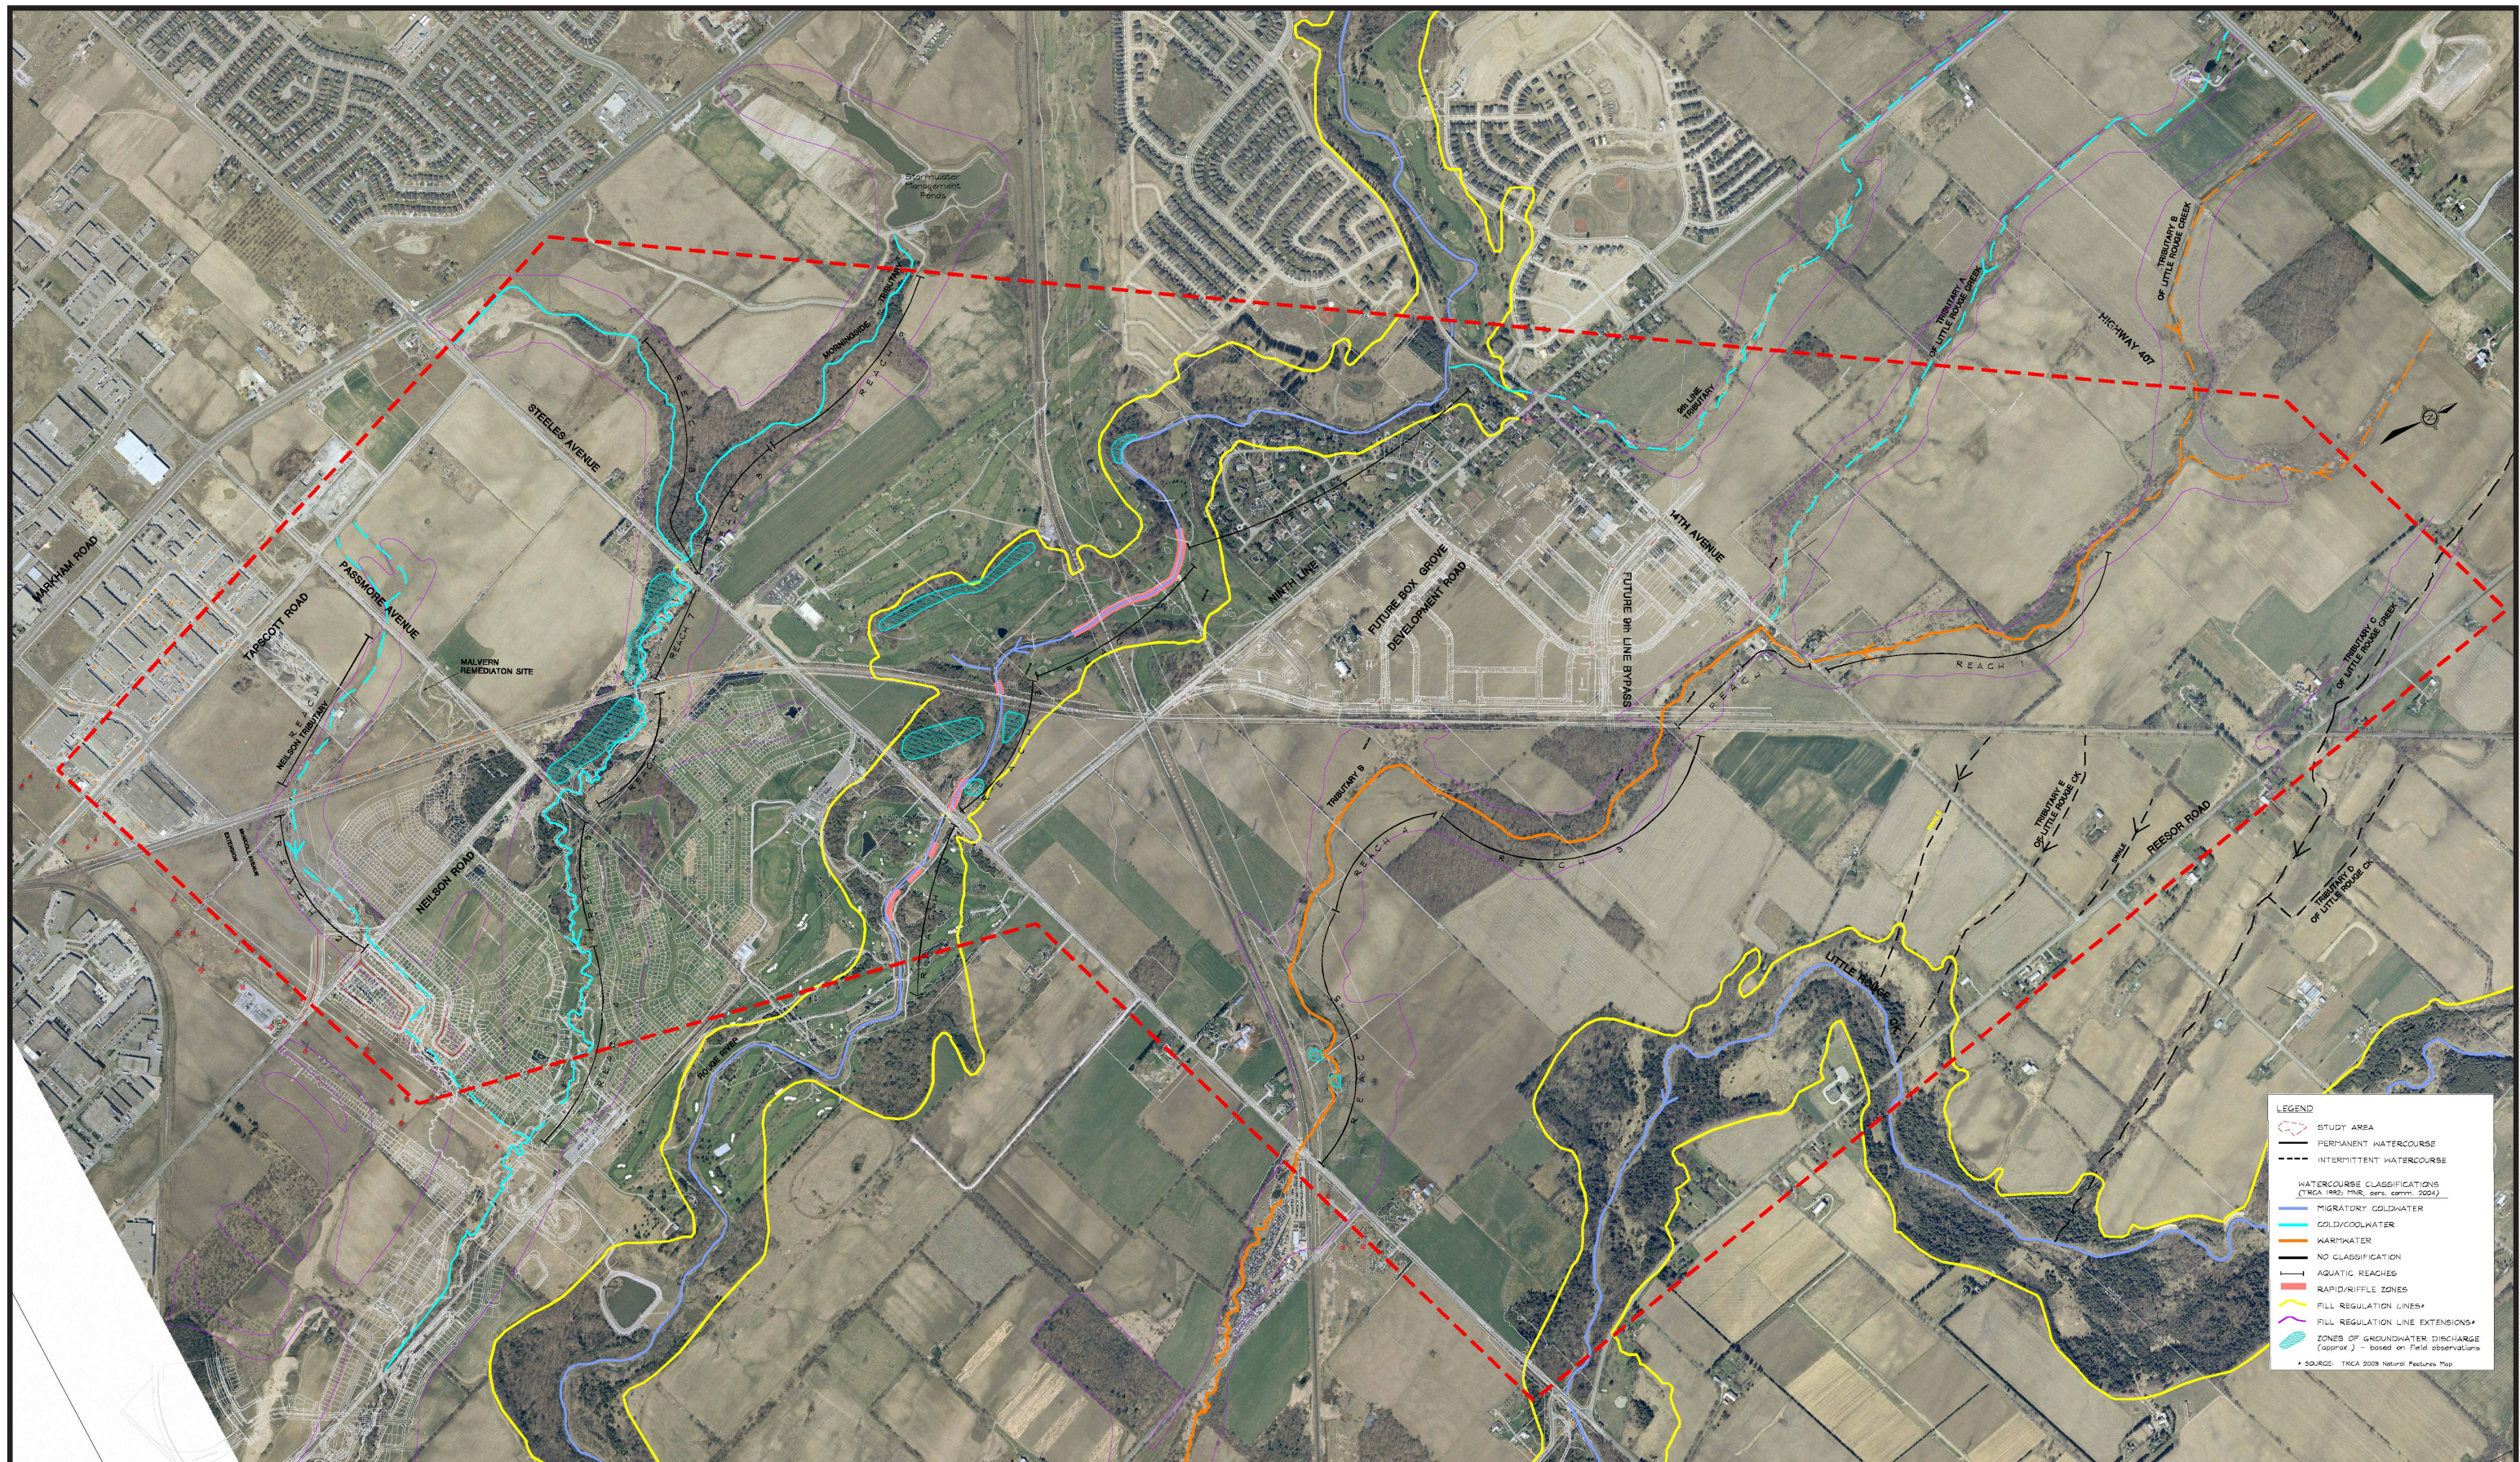
AQUATIC FEATURES

Little Rouge Creek. These are areas of groundwater discharge, either identified (i.e., based on seepage observations) or inferred, based on depth to groundwater in well records. Approximate locations of groundwater seepage observed in the field or identified in background reports are shown on Exhibit 4-8.

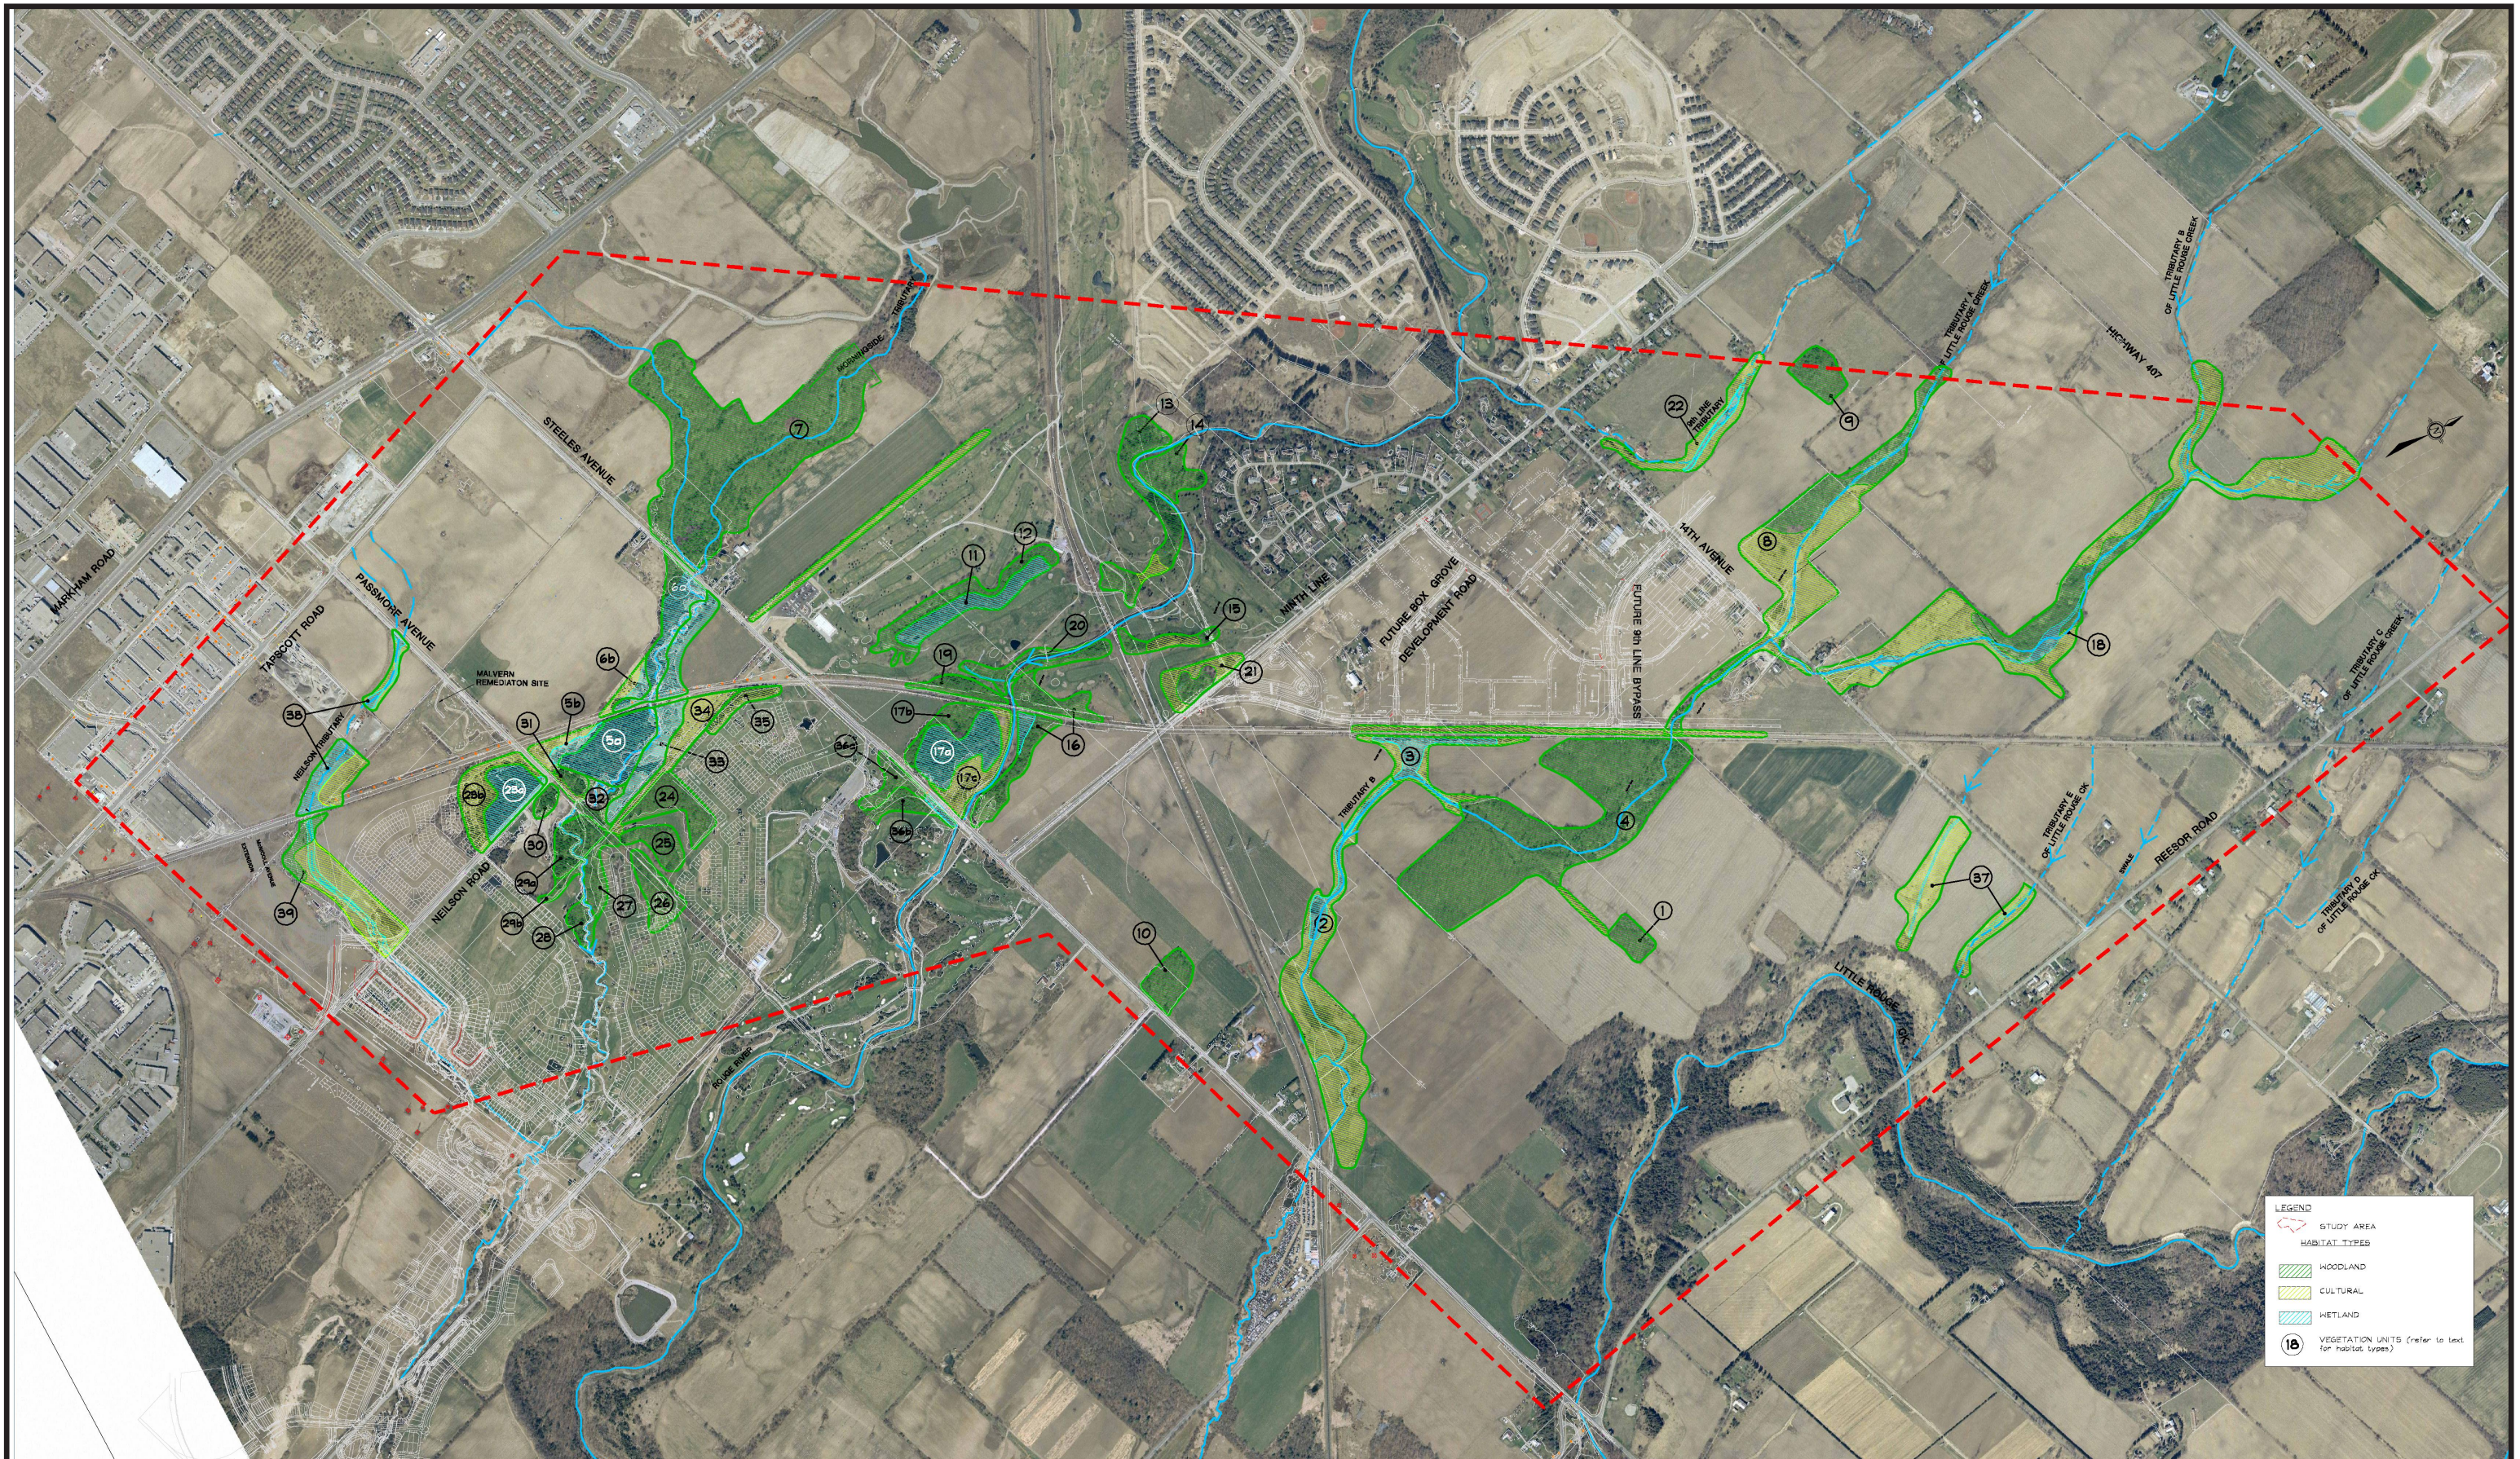
VEGETATION

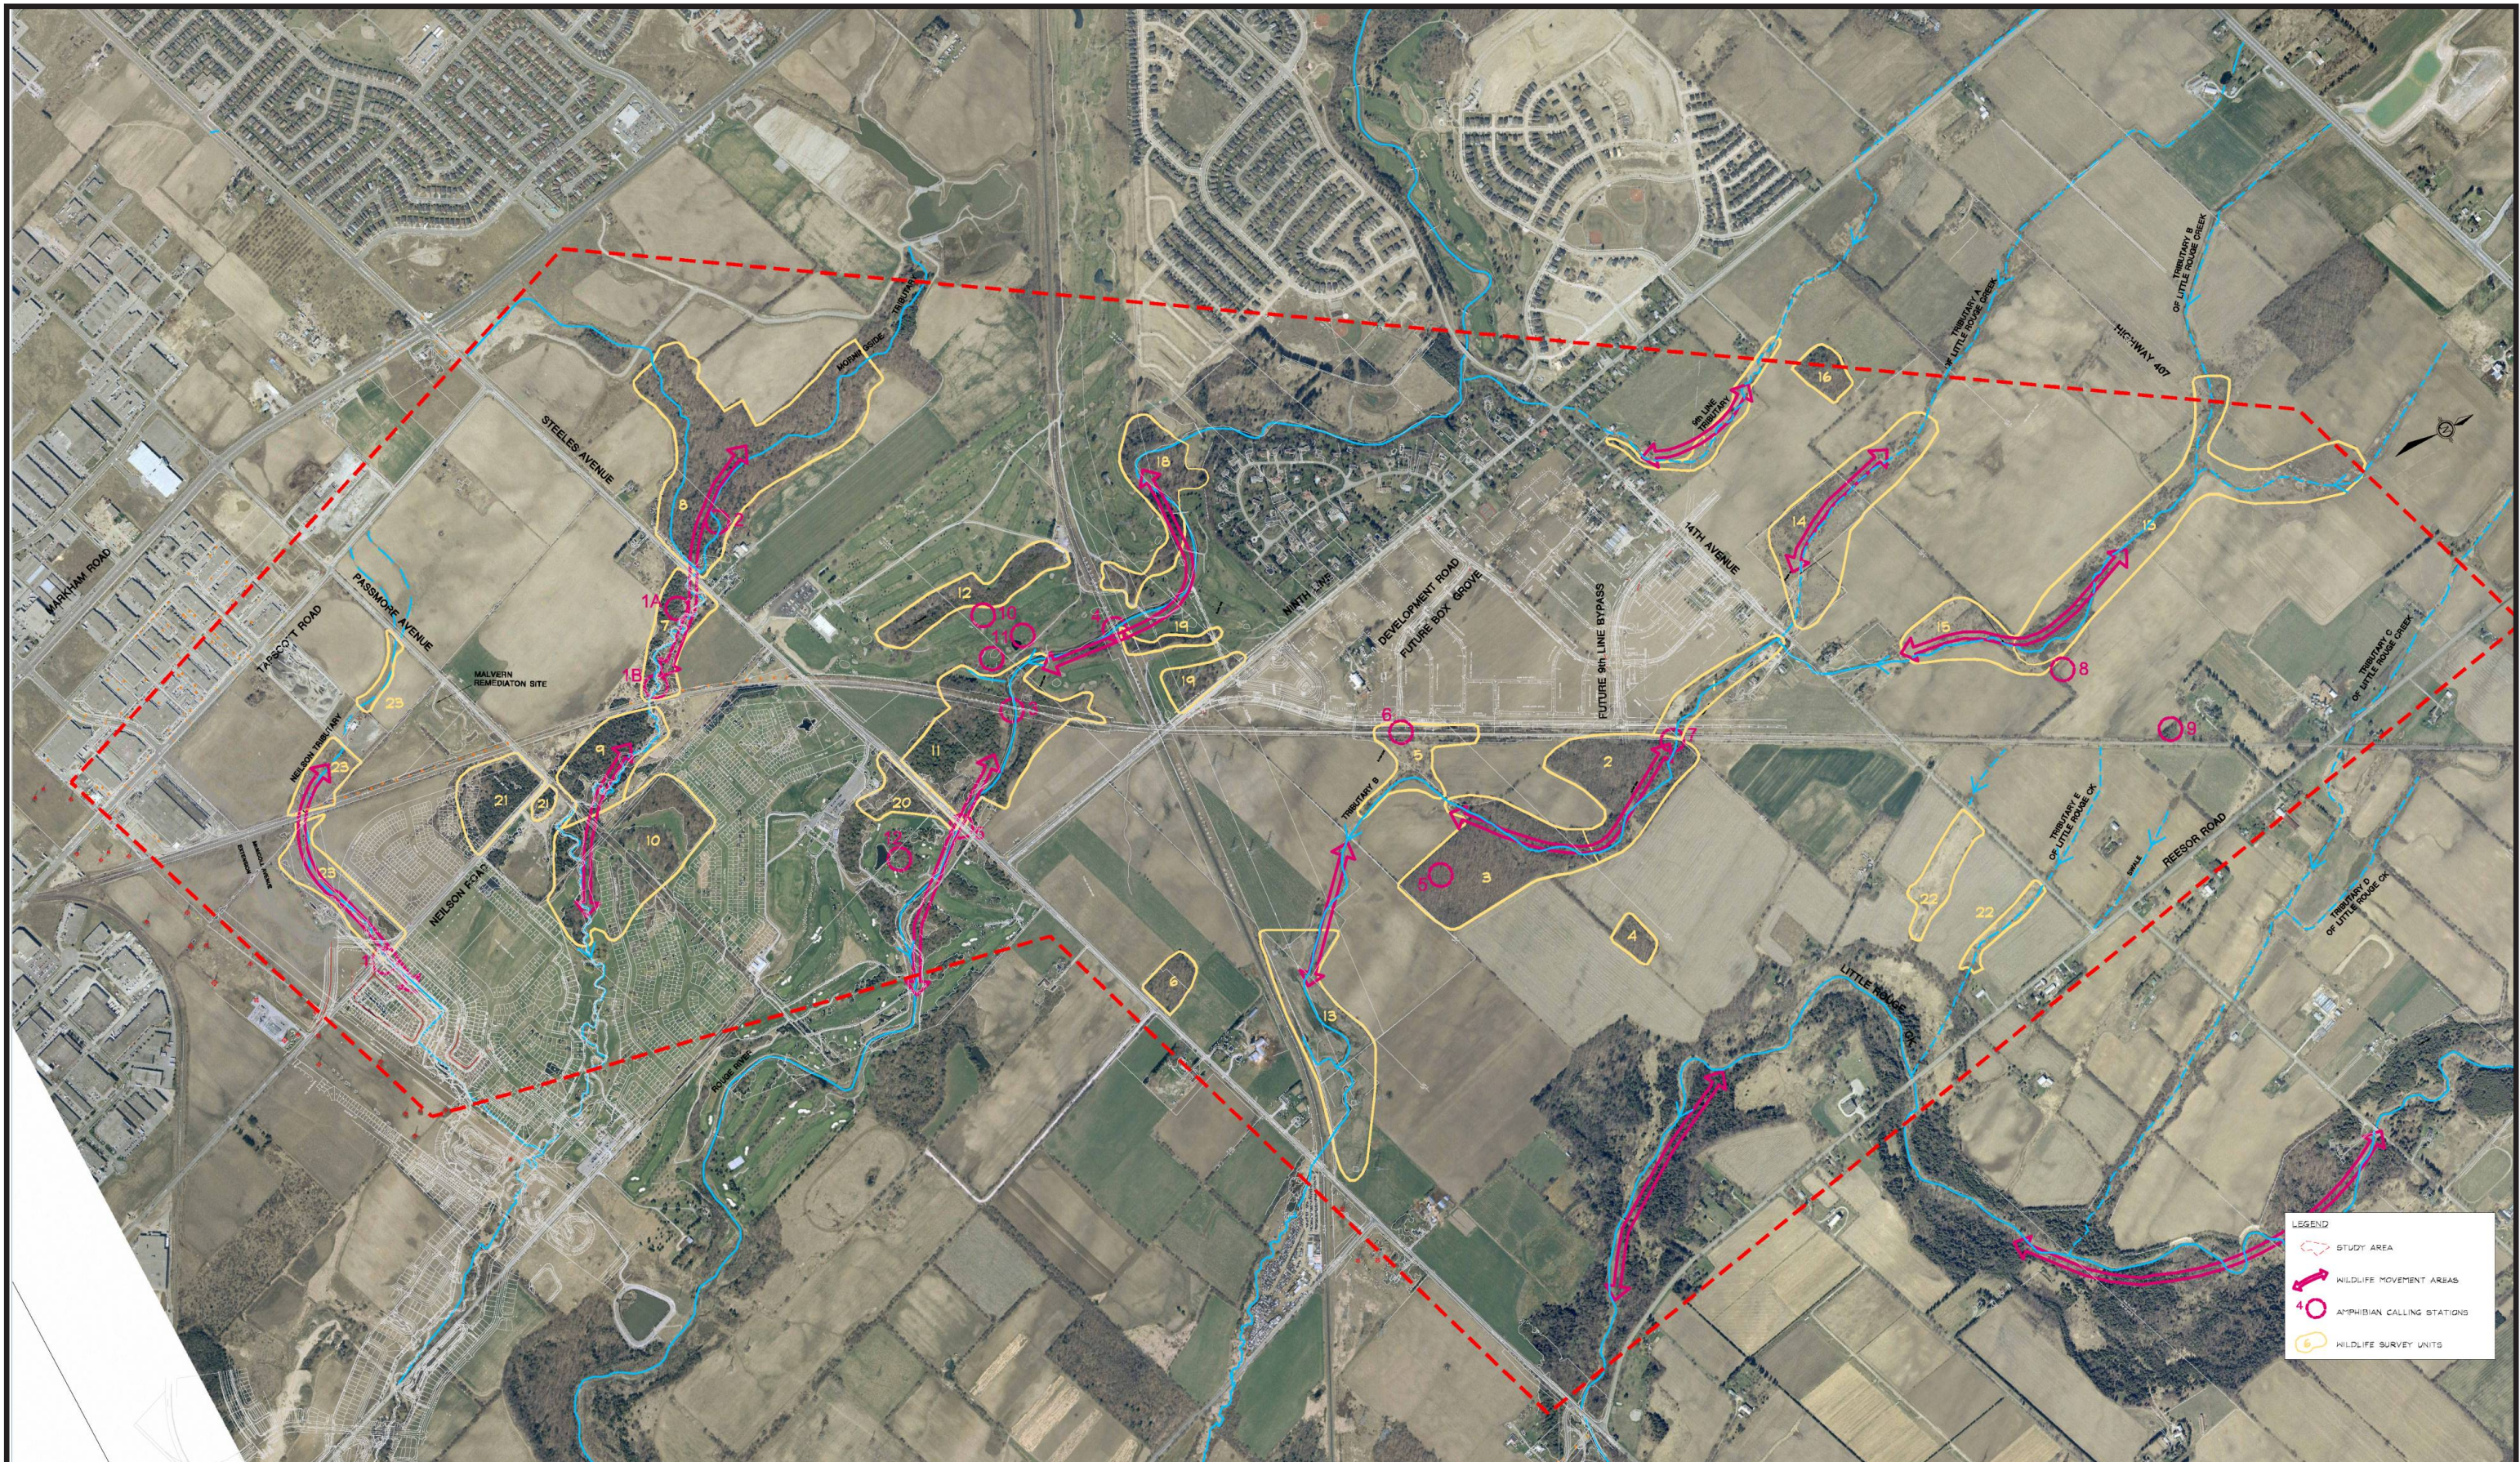
- STUDY AREA
- ↔ WILDLIFE MOVEMENT AREAS
- AMPHIBIAN CALLING STATIONS
- WILDLIFE SURVEY UNITS

A total of 23 wildlife survey units, as shown on Exhibit 4-10, were assessed during a 3 season inventory, with a total field effort of more than 24 hours over 4 days (plus incidental observations during all field surveys – more than 100 person hours in the field).
